2m4
L.S.U. Earth Resources Report
AOP No. 3
December, 1973

A Study of
Sediment Transport and Erosion in
the Fourchon Area of South Louisiana

A STUDY OF
SEDIMENT TRANSPORT AND EROSION IN
THE FOURCHON AREA OF SOUTH LOUISIANA

SYNOPSIS

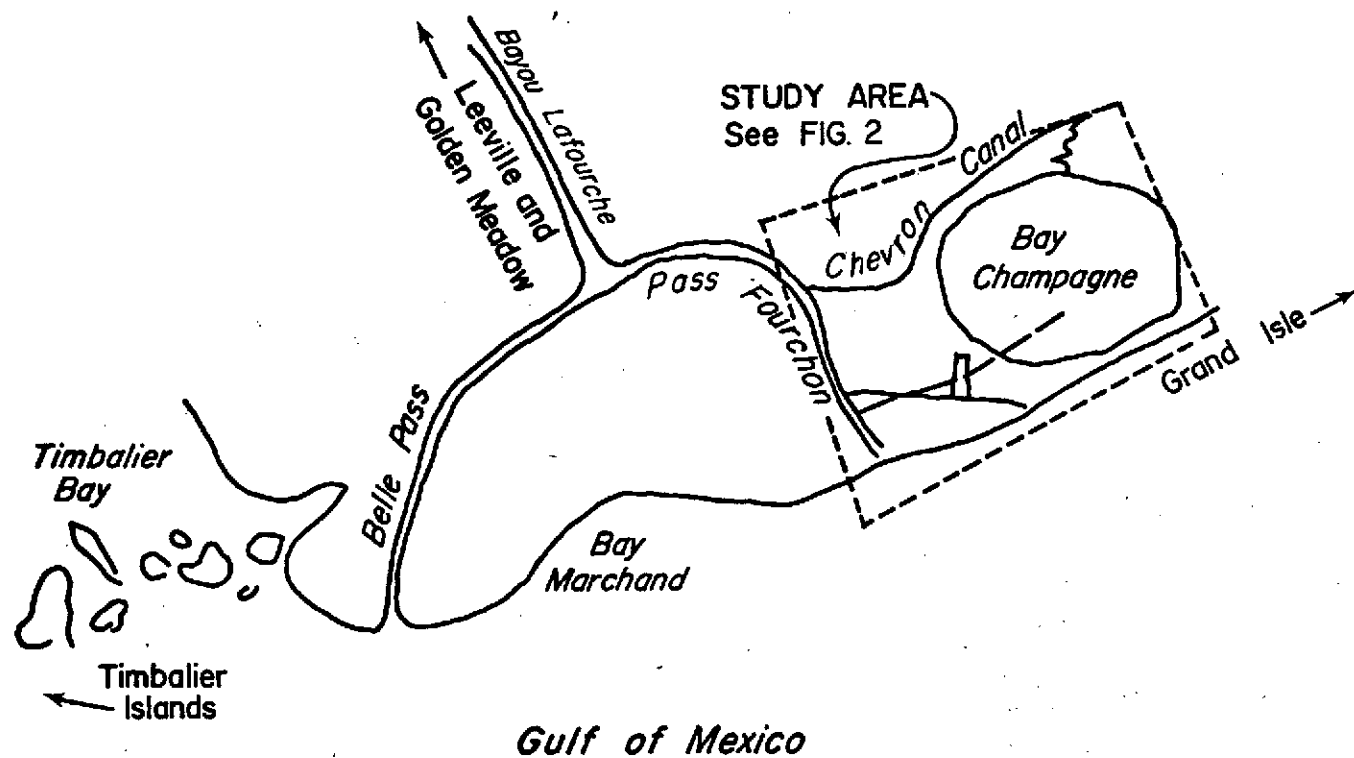
FIGURE 1.-- Map of western margin of eastern lobe of Old Lafourche Delta showing study area (Fourchon). Dashed line marked P.S.L. shows present shoreline. Map taken from Shepard & Wanless, 1971, and is based on USDA aerial photographs taken in 1953. No scale is given.

During 1973, work continued in the Fourchon area, between Leeville and Grand Isle, (Figure 1) in Lafourche Parish, Louisiana, and was extended to the brackish marsh in the Pointe au Chien area, south of Houma in Terrabonne Parish.

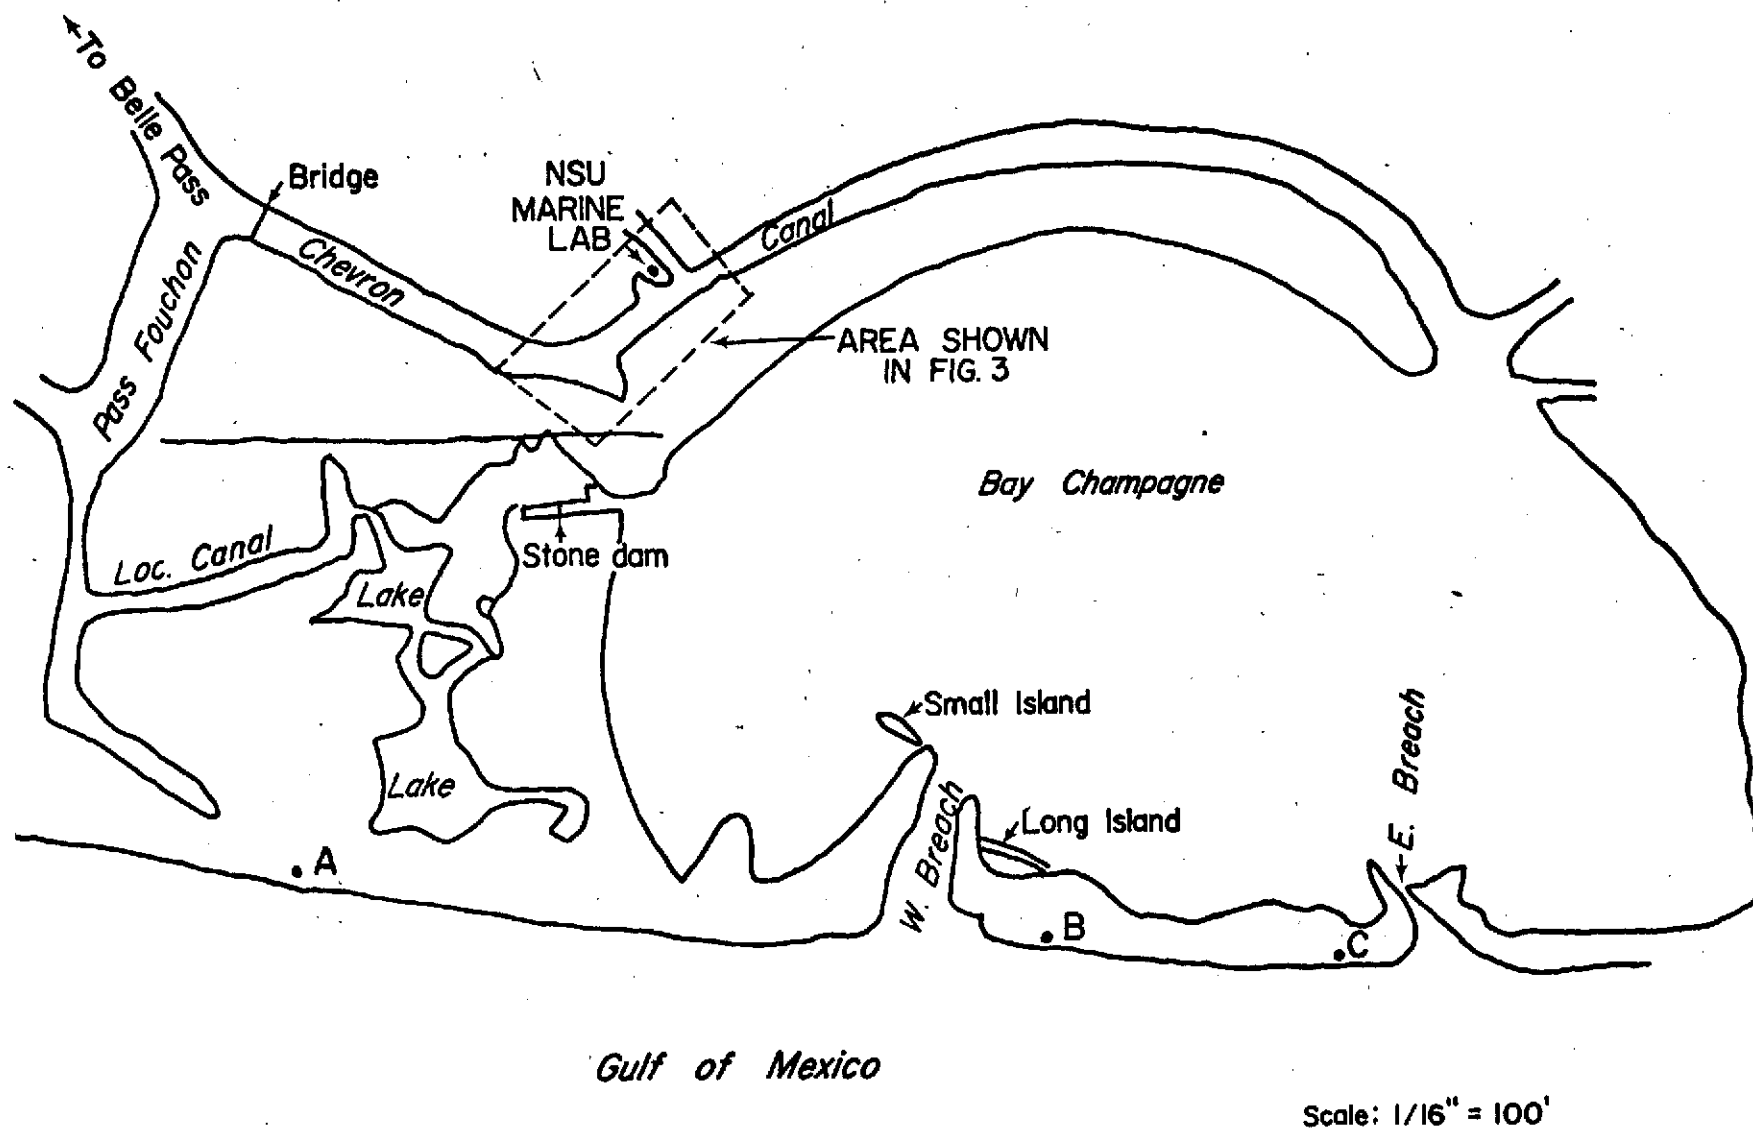
FIGURE 2.-- Location map of Fourchon area, June 1973 photographs

The dimensions of several man-made objects which would remain constant over a long period of time were measured in the Fourchon area. These included the bridge across Chevron Canal (Figure 2) and a small stone dam (Figure 2) which were used to scale the photographs. The original widths of canals and beaches and erosion factors were measured from photographs from the ERL, NASA Mississippi (Table I). In addition, profiles across Chevron Canal and current velocities and directions were obtained and compared with data from 1972. Photographs typical of the ones used are included in the attached packet.

(locations of all points mentioned above are shown in Fig. 2)

** Locations are located on Fig. 2.

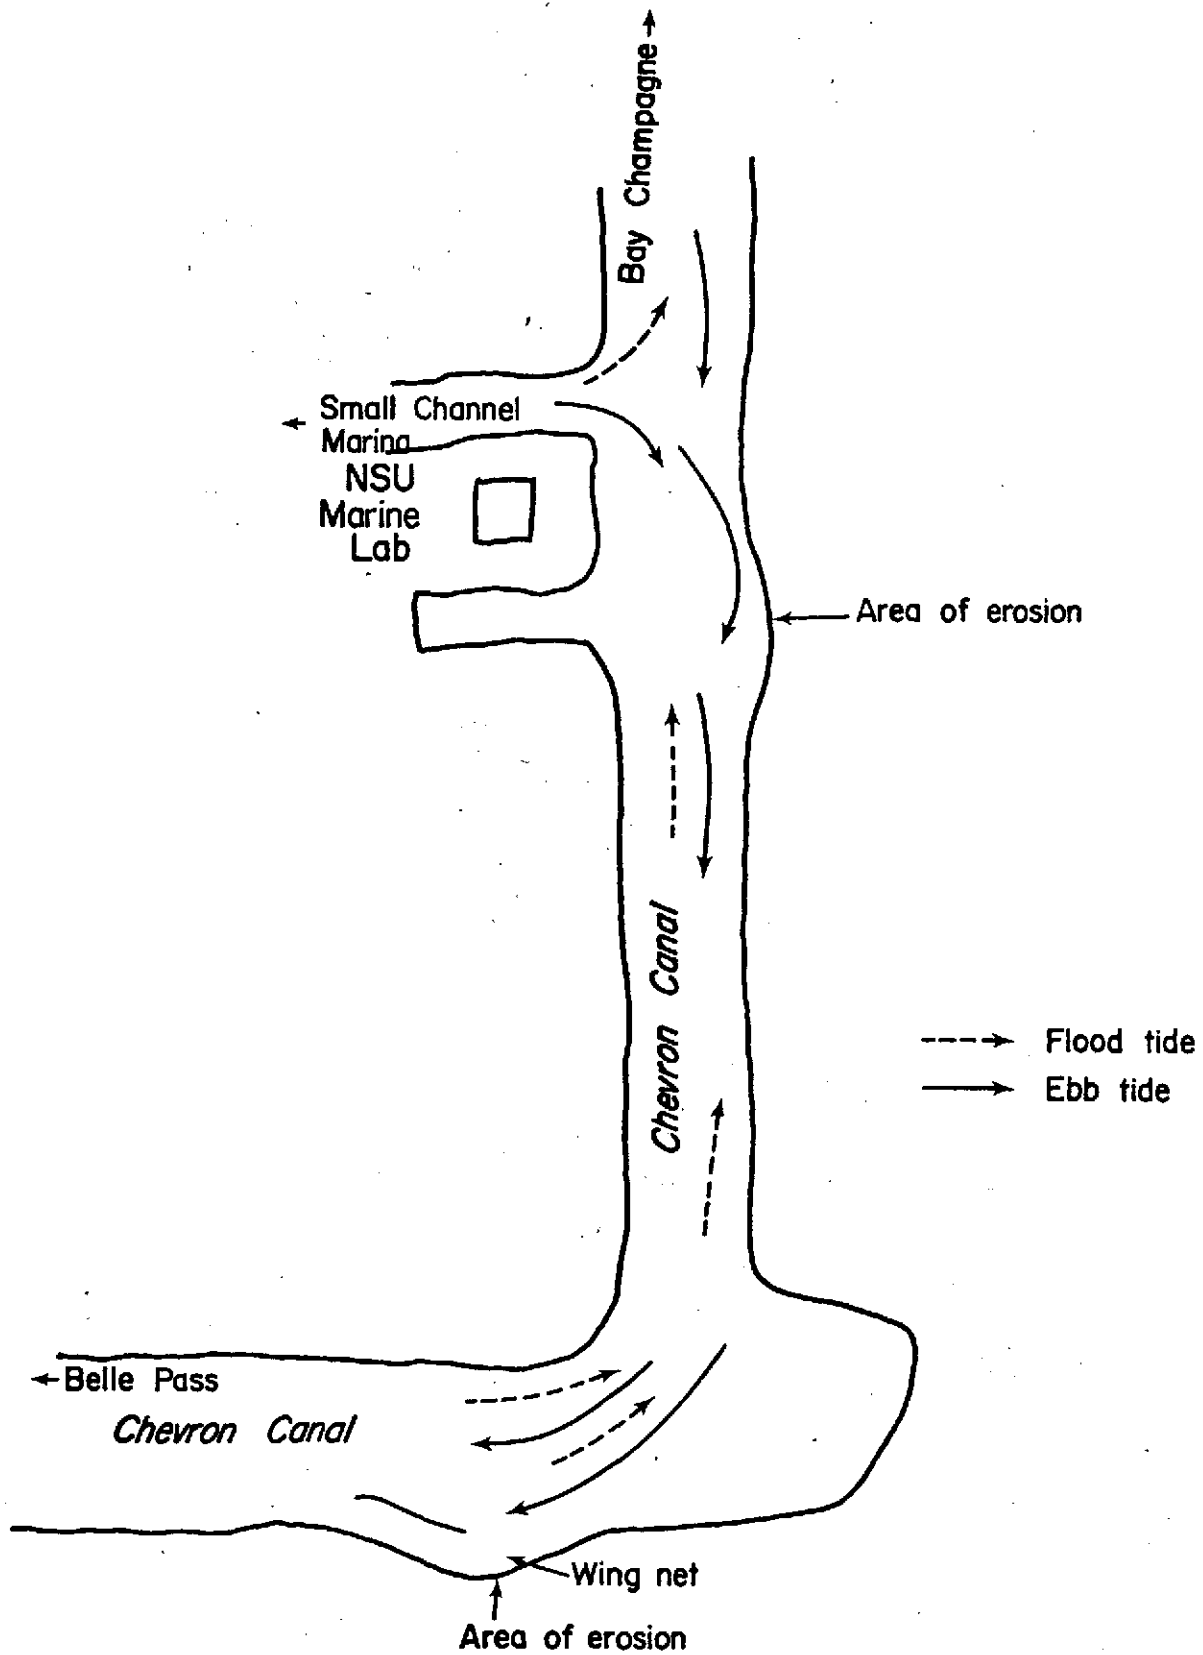
FIGURE 3.-- Erosion in Chevron Canal (no scale)

Studies in the Fourchon area were focused on a section of the Chevron Canal between Nicholls State University Marine Laboratory and the bridge over the canal (Figures 2 and 3) and a section of beach between Pass Fourchon and the eastern side of Bay Cahmpagne. Erosion in both places was noticable from August 1972 to May 1973 (Table III).

In the Chevron Canal erosion was most apparent on the east bank of the canal opposite the marine laboratory and immediately west of a right angle turn south of the laboratory (Figure 3). These areas of erosion are clearly distinguished in the aerial photographs as indentations in the bank. At the site directly opposite the laboratory, the spoil bank is completely breached allowing marsh water to drain into the canal. In addition, the eroded area is subject to high velocities from a boat channel which connects with Chevron Canal at a point adjacent to the laboratory property. High velocities in the channel deflect tidal currents toward the eroding bank. The constant use of these channels by high speed motor boats contributes to the total amount of erosion. The situation is shown in Figure 3.

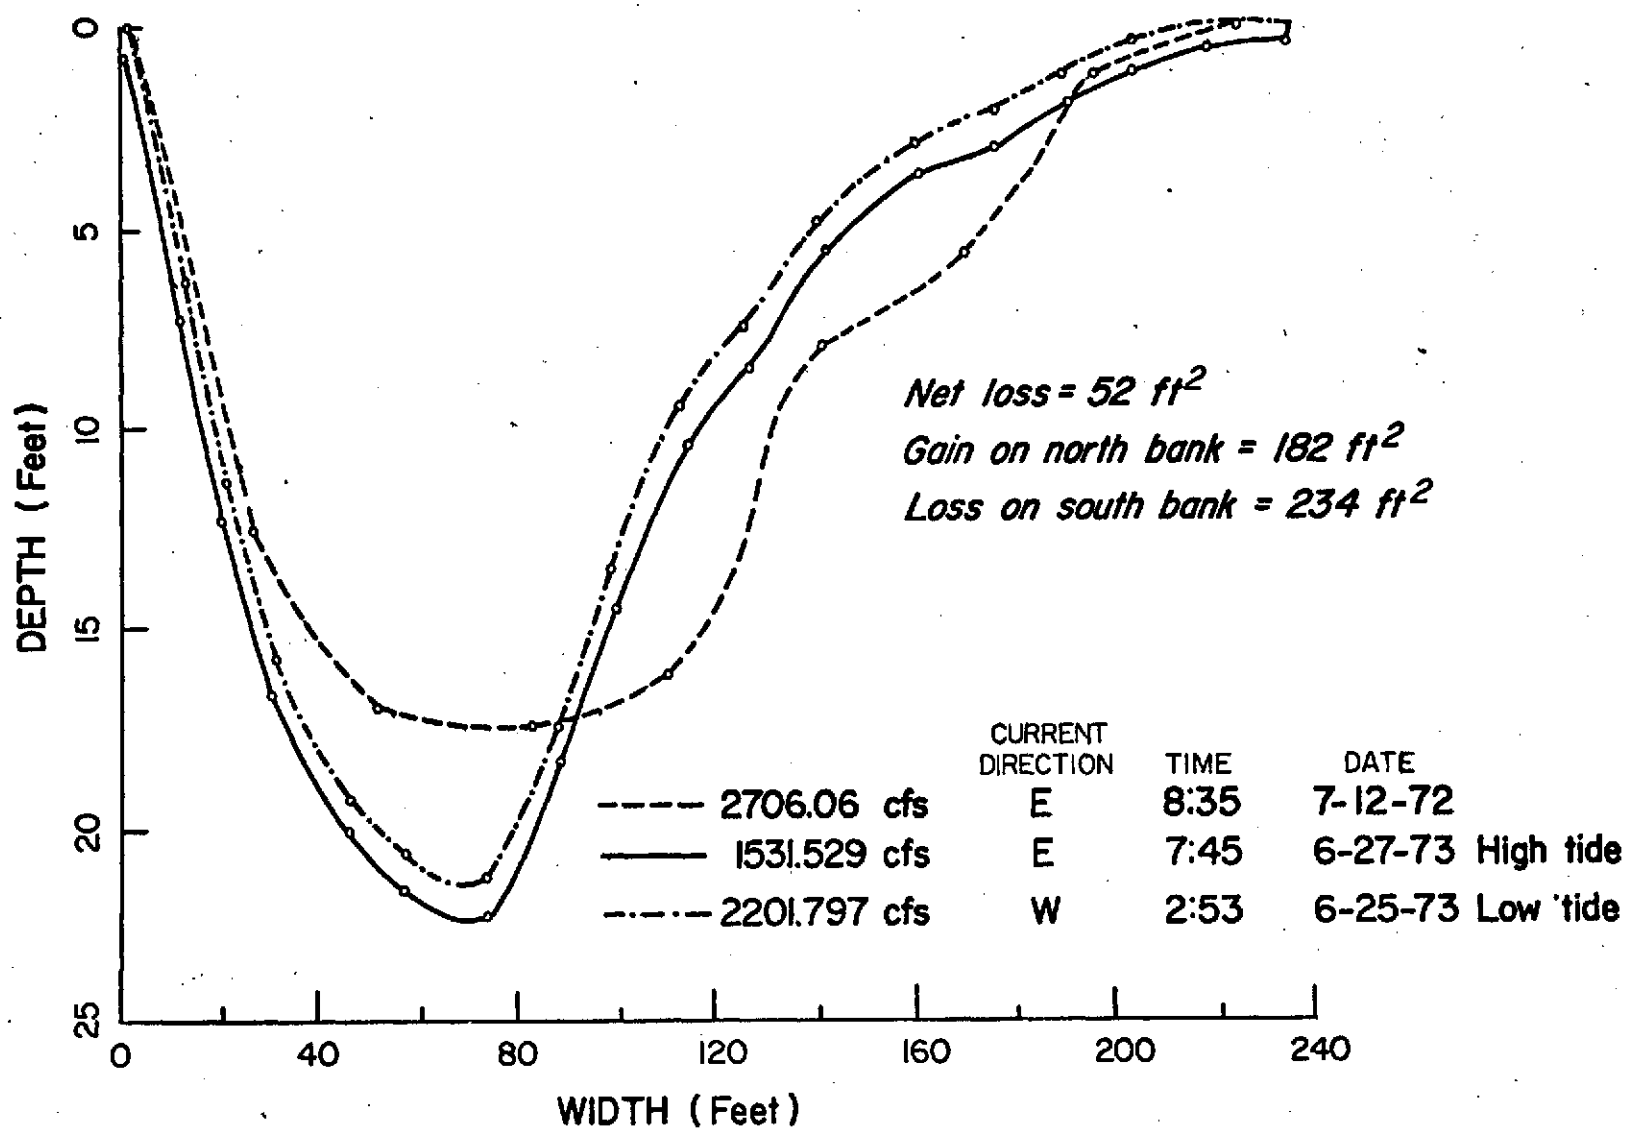
FIGURE 4.-- Profile Across Chevron Canal at Wing Net

Cross-sectional profiles obtained for Chevron Canal during the summer of 1972 and again in 1973 (Figure 4) show a net deposition of sediment on the north side and net erosion on the south side. Several results are noted: (1) there has been a net loss of 52 square feet for the entire profile, (2) the northern side of the canal has shallowed while the southern side has deepened, and (3) the channel has widened by about 11 feet during the year. The right angle turn in the channel generates faster velocities on the outside of curve and slower velocities on the inside, which results in erosion on the outside and deposition on the inside, as is shown in Figure 3. Velocities are quite strong (see Table III) and the effect is the same as that which occurs in meandering rivers. As a result, the north bank may have migrated as much as 24 feet southward. Due to lack of fixed points and scale differences in photos, this measurement is difficult and is considered only approximate. Approximately 30 feet of the bank has been eroded but at this writing, the spoil bank has not been breached.

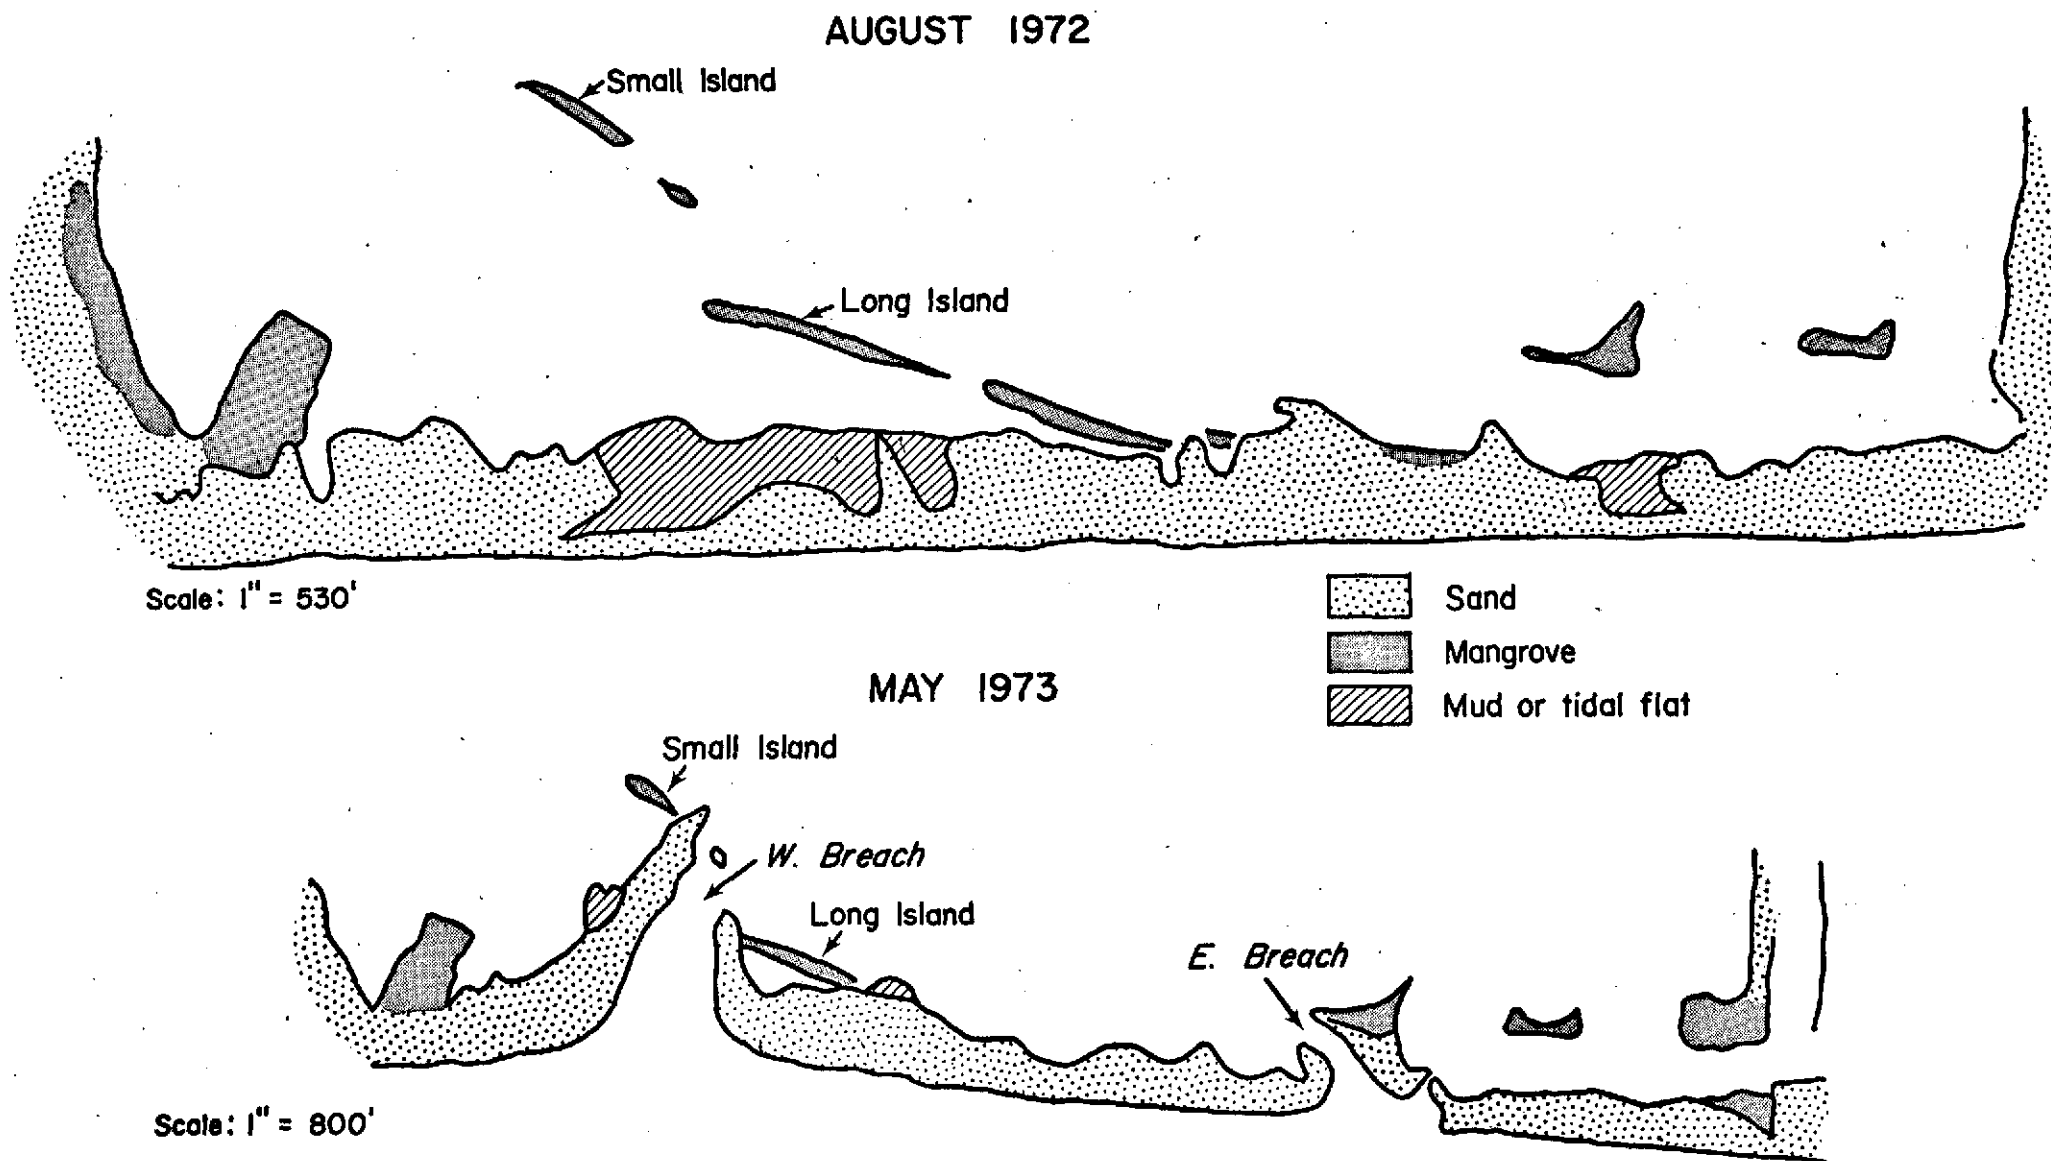
FIGURE 5.-- Erosion of Baymouth -- Bay Champagne

During the year, two breaches were opened in the bar across Bay Champagne. Sand now extends more than 1,000 feet northward into Bay Champagne (Figure 5) where it has obliterated several small mangrove islands. The bar had completely separated Bay Champagne from the Gulf of Mexico, forcing the drainage from the Bay to run through Chevron Canal and several small tidal channels in the marsh. The breaches, however, may have changed the hydrology, and there is now direct communication between the Gulf and Bay Champagne causing current reversals at certain times. This is particularly true during the outgoing tidal periods. The breaches are the result of wave action during high water as the bar was breached from the Gulf side. It is not known when the bar was breached and at the moment, it appears that the breaches are being healed, suggesting that they are temporary. The opening of breaches from time to time can be expected and this would temporarily alter the drainage in the marsh, as shown in Figures 6A, 6B, and 6C and consequently the ecological balance.

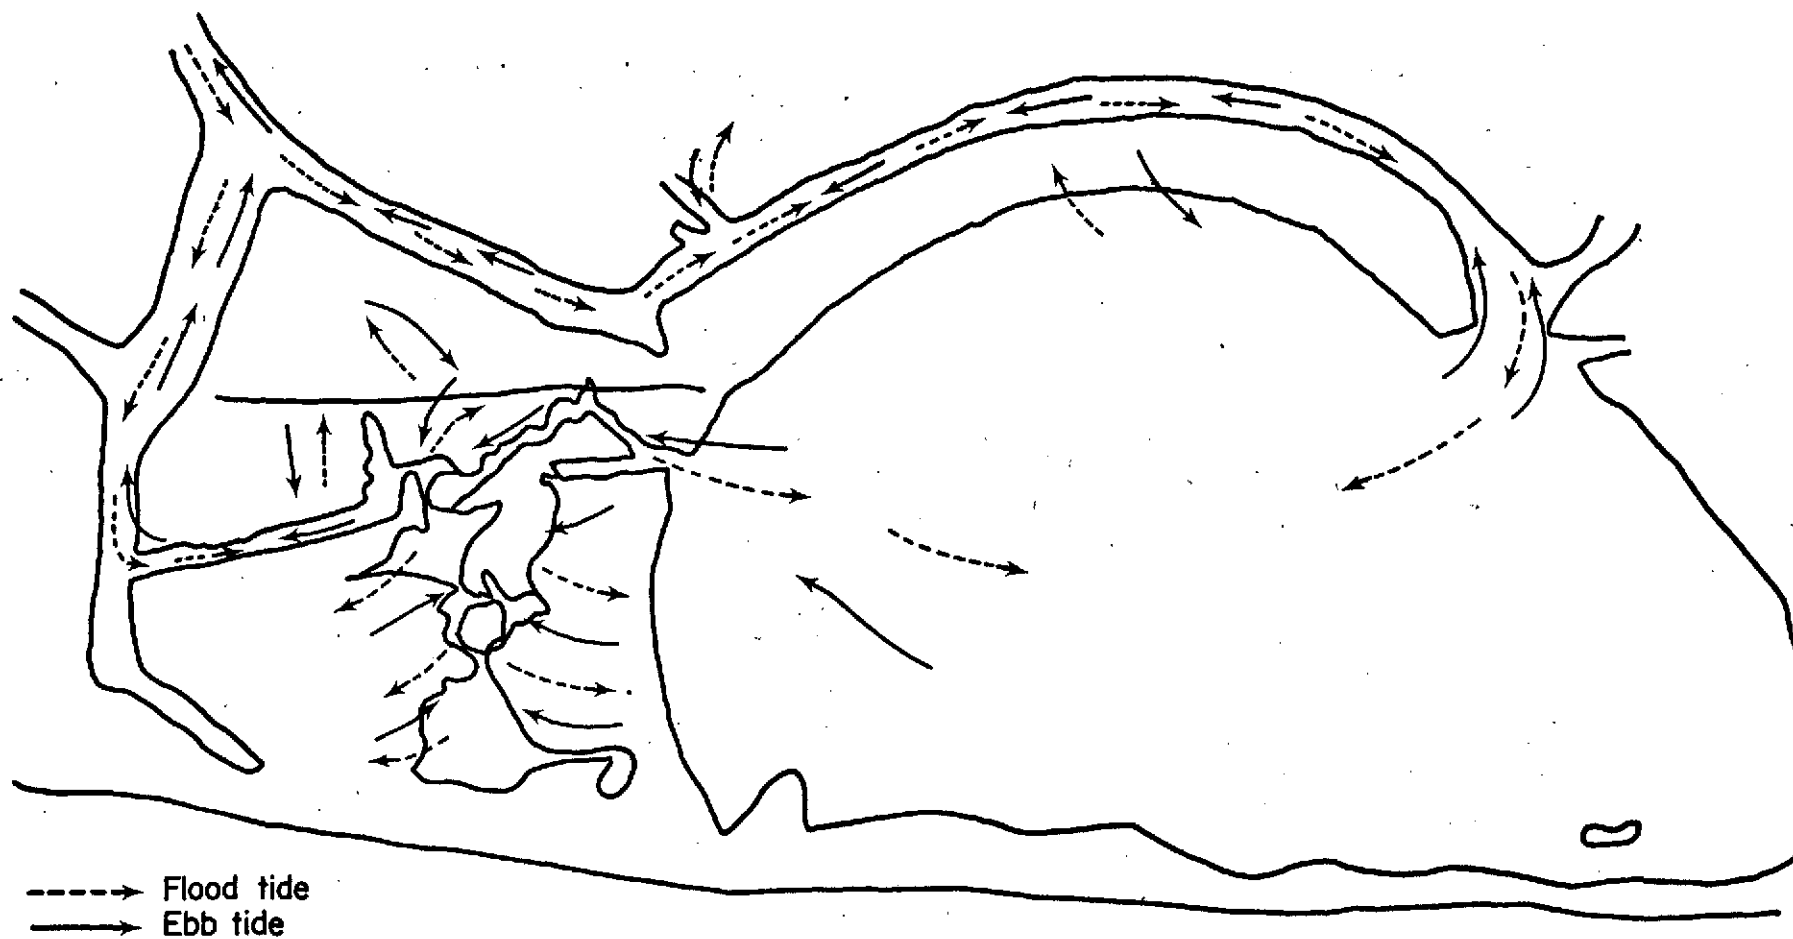
FIGURE 6A.-- Drainage of Bay Champagne and Fourchon Marsh
when breaches are closed

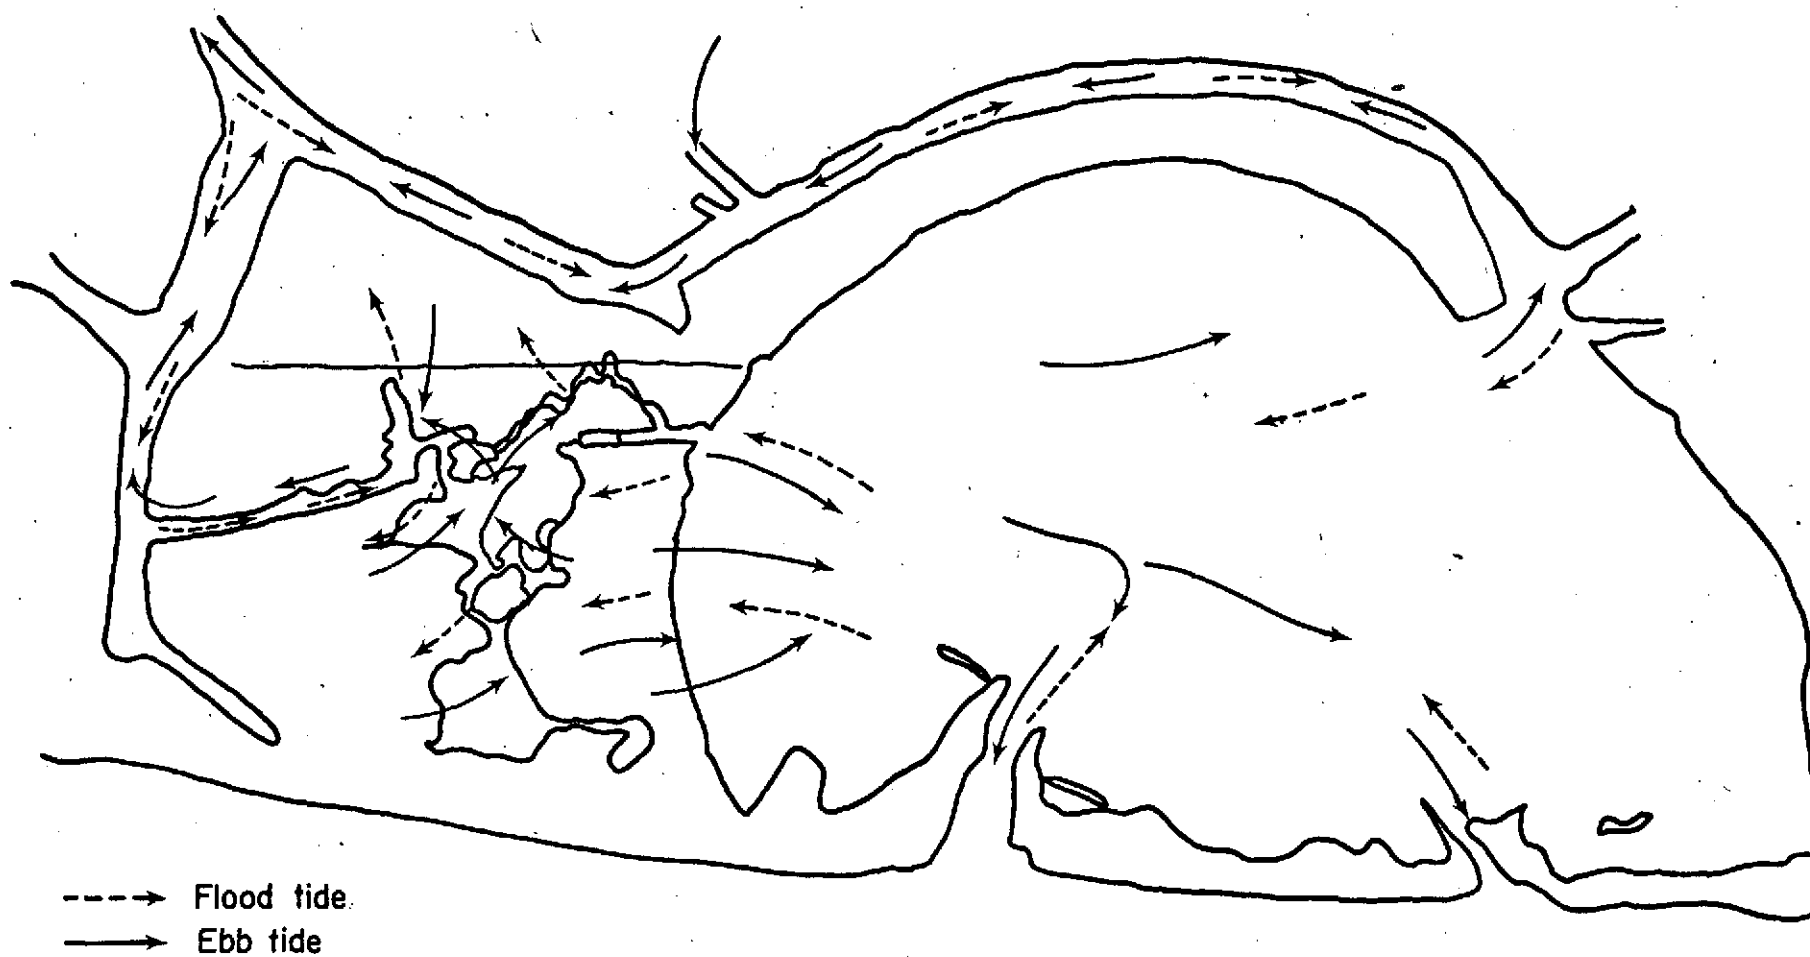
FIGURE 6B.-- Drainage of Bay Champagne and Fourchon Marsh
when Breaches are open

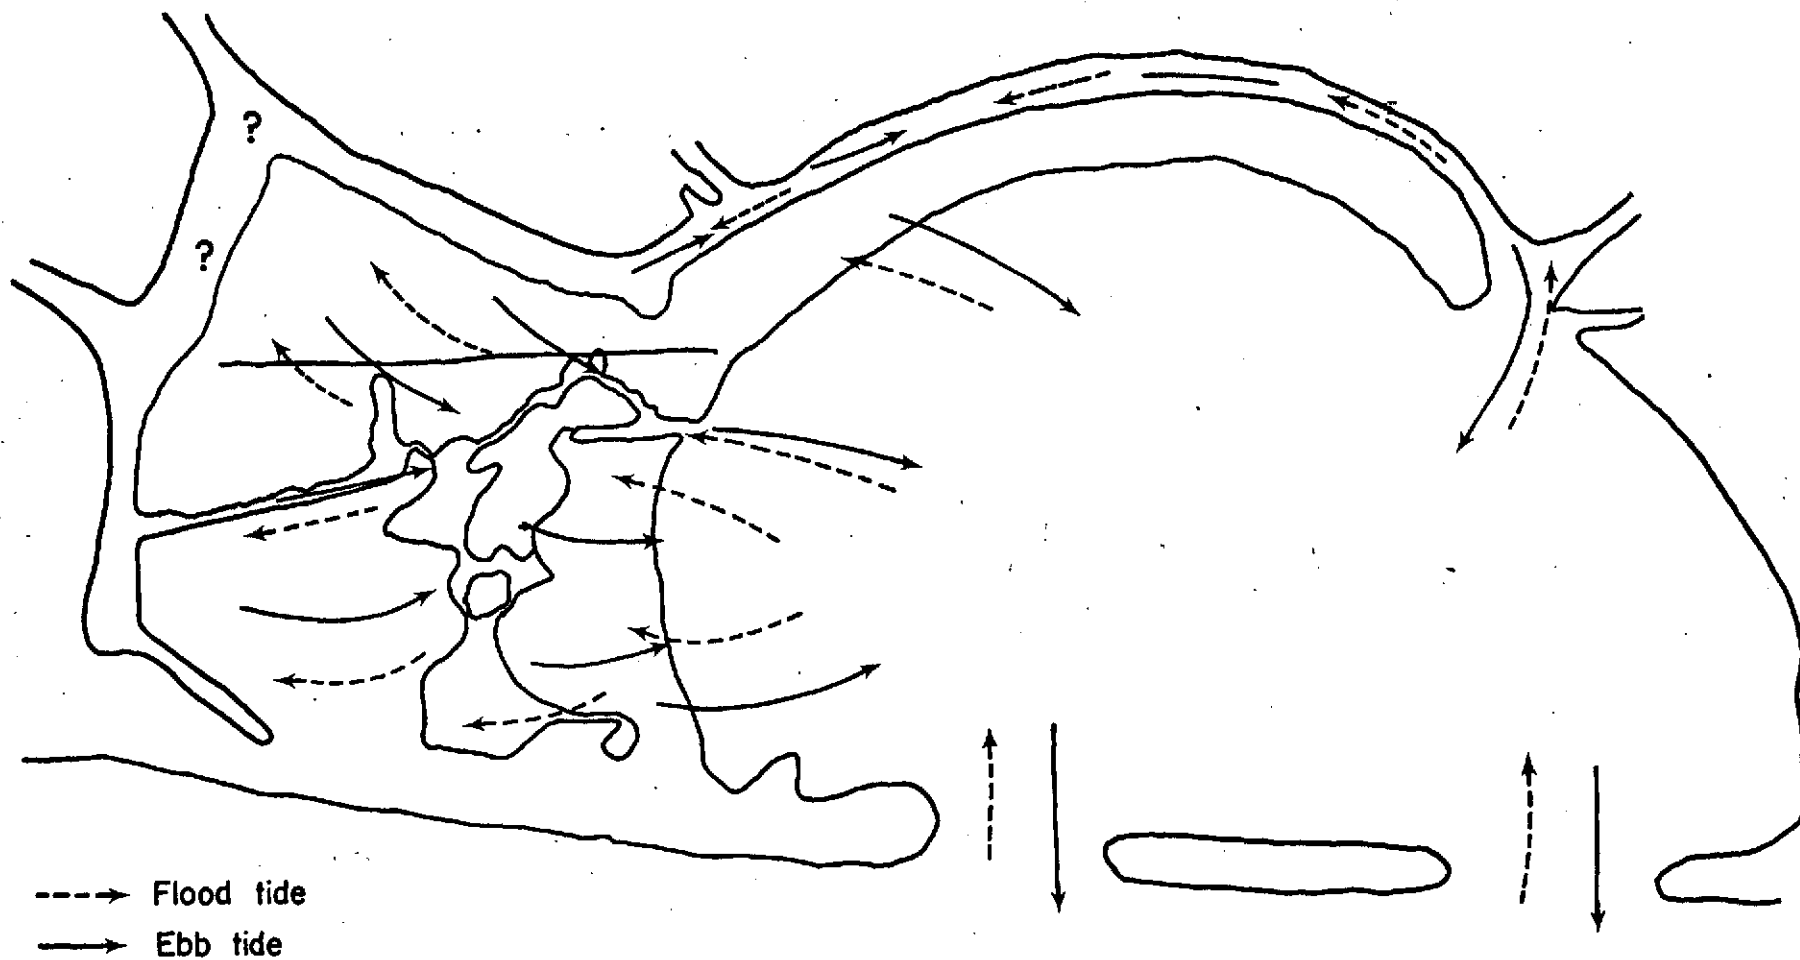
FIGURE 6C.-- Drainage if breaches were widened or deepened
or bar disappeared

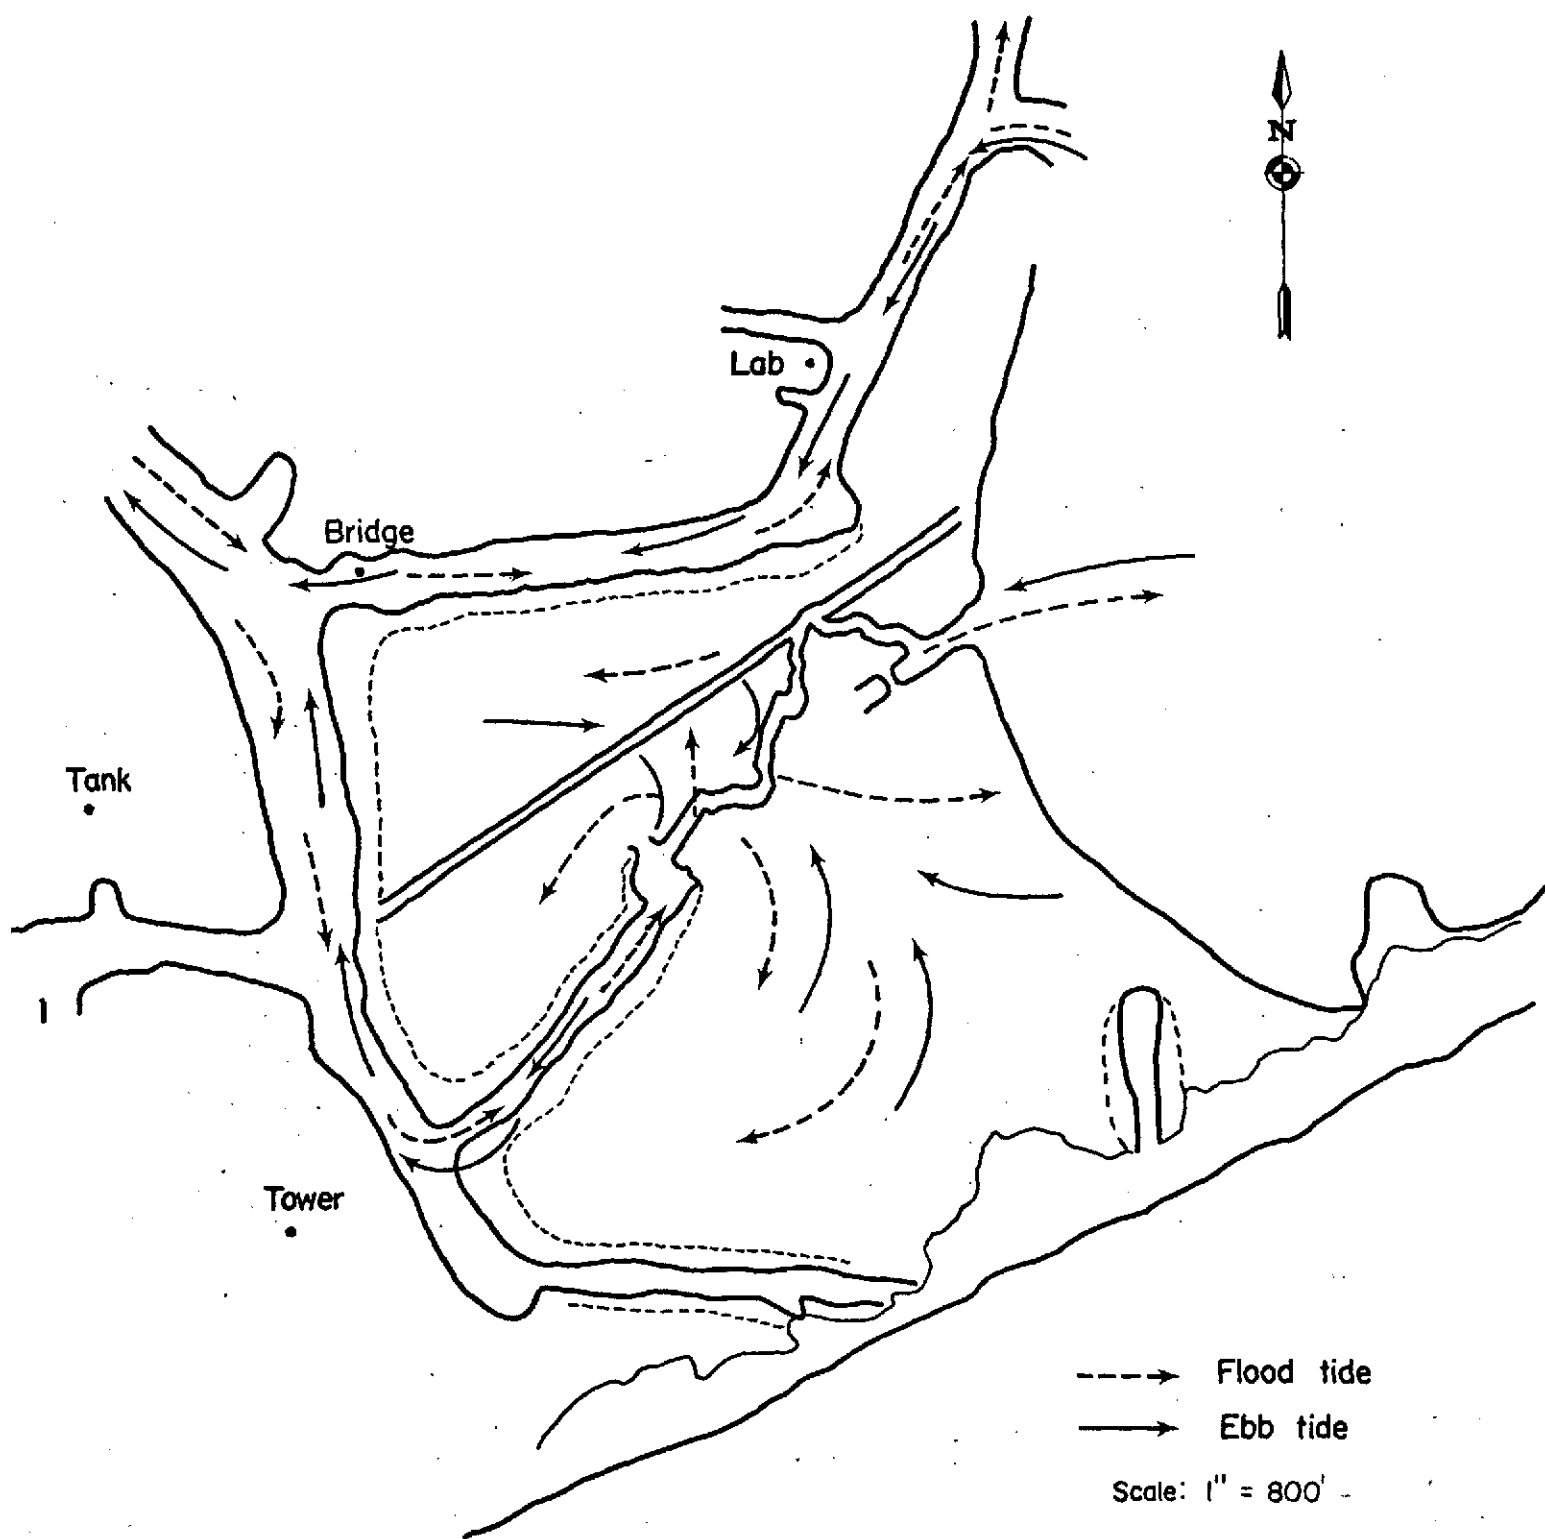
FIGURE 7A.-- Normal Drainage Fourchon Marsh

not occur. Second, a road is being constructed from the bridge to the beach, adjacent to Pass Fourchon. A location canal which normally drains Lake Champagne and the marsh has been completely filled in blocking normal drainage. (Figures 7A and 7B) As a result, the marsh must now drain into Bay Champagne rather than into Pass Fourchon as it formally did. These developments are too recent (within the last two weeks of this report) to evaluate their impact on the surrounding areas, but may result in changes in areas of erosion and deposition within the marsh.

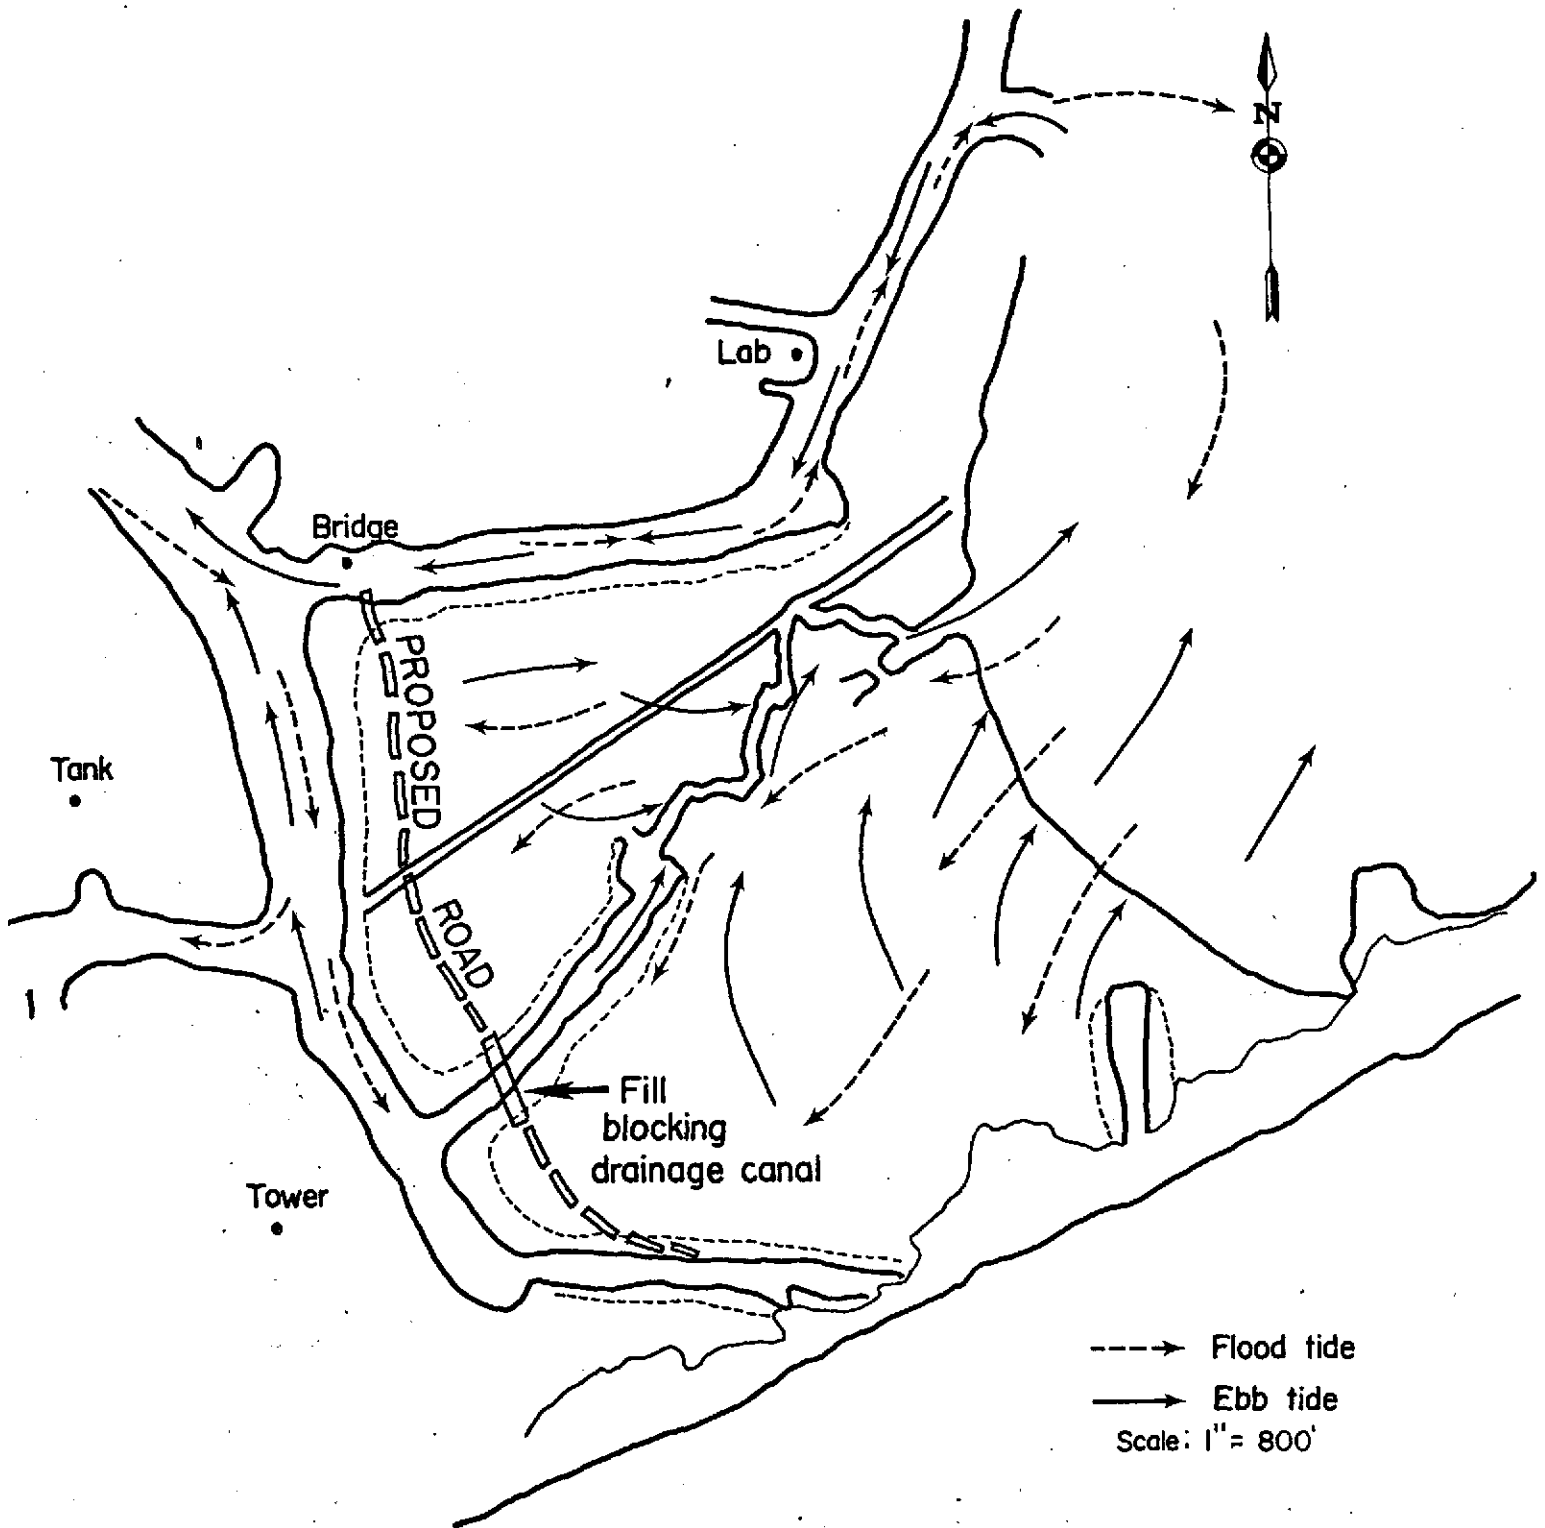
FIGURE 7B.-- Blockage of Location Canal and Resulting Drainage
